# Repair and Modification of NZ Railway Tunnels

Graham Ramsay BE(Hons) PhD FIPENZ CPEng

Technical Director, Beca Infrastructure Limited

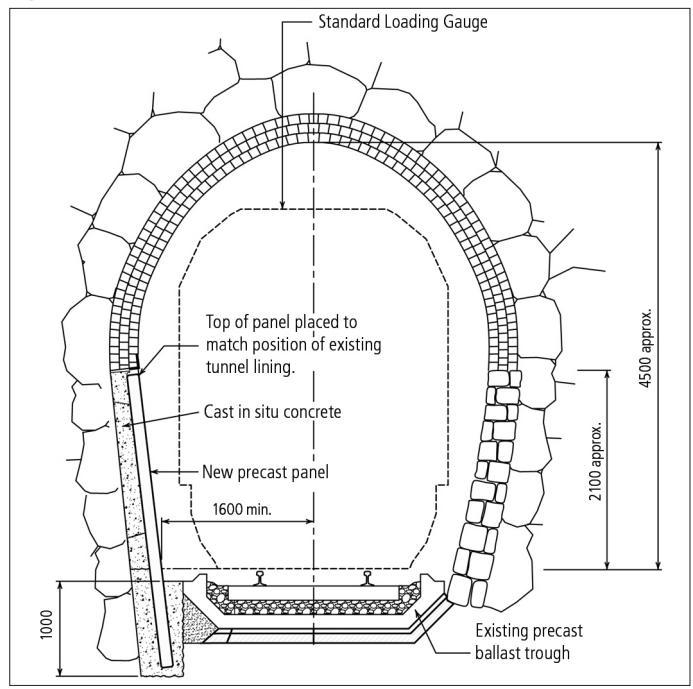
#### Figure 1 Mihiwaka Tunnel repair

Sections of lining in at least two tunnels (NIMT Tunnel 4 and MSL Tunnel 5 Mihiwaka) have been replaced but details of the reasons for the replacement, the design assumptions, or the construction methodology are unknown. In both cases the new lining is to the same horseshoe profile as the original. Further sections of the lining at Mihiwaka were replaced by KRN in 2009. The tunnel is constructed through volcanic deposits with some sections being unlined and the remainder lined with ashlar masonry in the walls and brick in the crown. Some sections within the lined length have exhibited significant bulging and longitudinal cracking.

Investigations and testing in the 1980s indicated the presence of swelling clay minerals within the breccia matrix. The bulging is generally confined within the walls and the inward movement is of the order of 200mm. It was deemed that if no action was taken the thrust line from the bulged walls would, at some time, pass outside the wall foundations with a risk of failure of the unreinforced masonry wall. KRN is replacing the bulging sections of wall in 1 metre wide hit and treble miss panels using a precast panel which performs two functions. Primarily it acts as formwork for in-situ concrete placed behind the panel and secondly as a component of the new structural wall. Details are shown in Figure 1.

face to enable the panel to act compositely with the concrete backfill as an unreinforced vertical load bearing wall. It was noted during construction that there was intimate contact between the back of the ashlar lining and the volcanic breccia which is attributed to swelling of the breccia. It was also noted that sections of the ashlar lining on the opposite side of the tunnel had been replaced with in-situ concrete at some time in the past. There are no formal records but anecdotal recollections report that the lining replacement was done in the 1950s.

There are no indications of cracking or bulging of the replacement concrete sections after 50+ years of service. Consideration was given to placing a 'compressible' polystyrene panel behind the in situ concrete to accommodate any future ground swelling. However, the compression available from the polystyrene is limited and the acceptable performance of the 50 year old repairs on the other side of the tunnel was taken as a precedent for a 'like' with 'like' design approach.

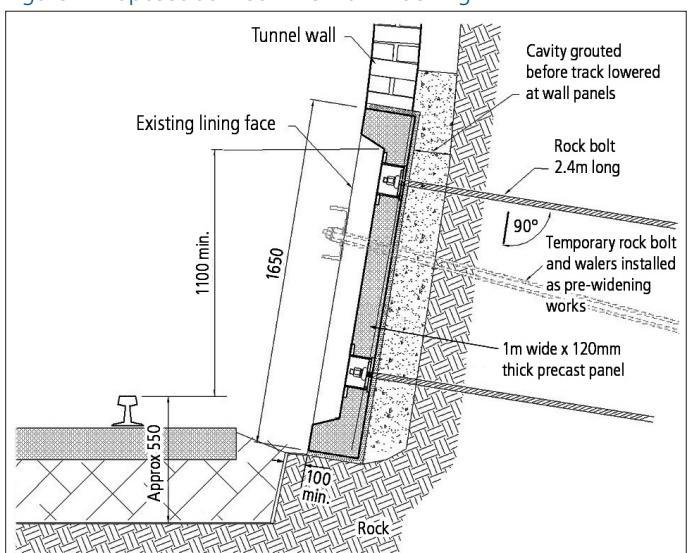
Part of the WRRP project (Gordon 2010) involves modifications to the Johnsonville commuter line to enable the new Matangi EMUs to pass through the tunnels. Tunnel invert lowering was identified as the primary means of achieving this. However, for programming reasons, modifications work needed to be undertaken before the characteristics of the new EMUs had been finalised. The initial analyses indicated that along approximately 210m of tunnel wall the clearances achievable with invert lowering alone would be insufficient and some wall modifications would be required. A contingency design was undertaken and Building Consents obtained for replacing the inclined lower brick wall with a precast panel with a recess using the arrangement shown in Figure 2. The panel and rock bolts were designed using the loads established for invert lowering as described in section 5.5.

When the final EMU characteristics became available it was established that the widening was unnecessary and the modifications did not proceed.

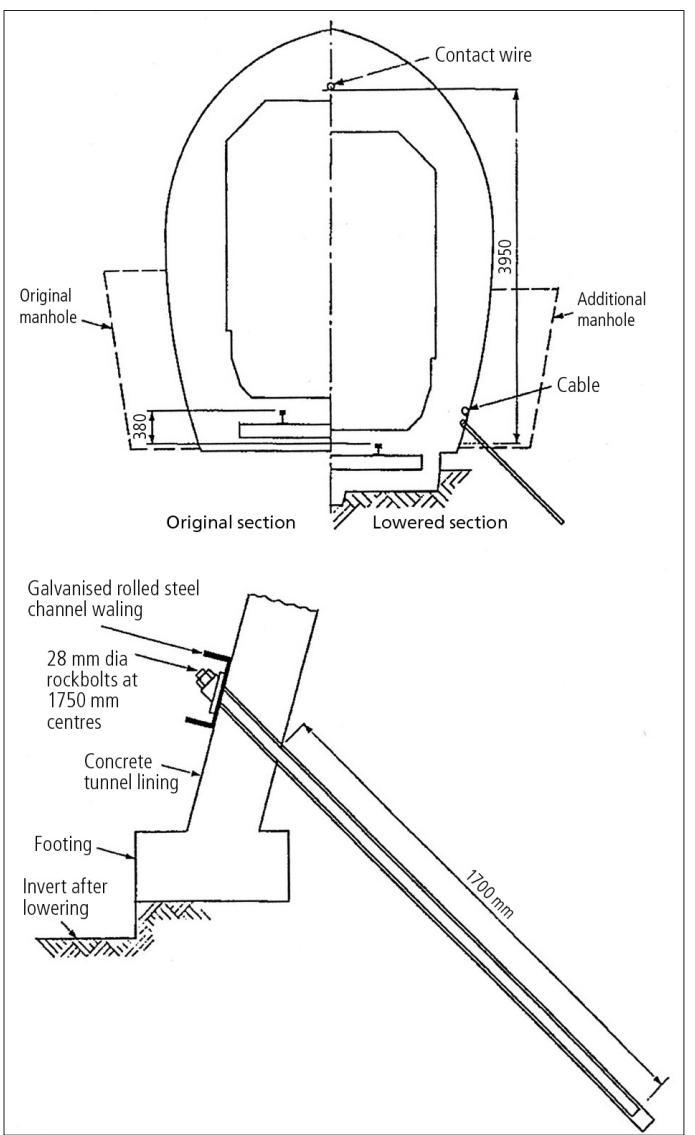
From previous projects indicative design bond stresses had been established. It had been noted that for consistent achievement of the pullout bond stress careful drilling of the hole to the correct depth and diameter was essential. This is because the system relies on a measured amount of grout introduced in a perforated tube (formed from two half shells) being forced out into the surrounding annulus by the introduction of a threaded rock-bolt driven with a percussion hammer.

This system had the advantage of not relying on mechanical anchorages which had been found to be problematical in papa. After installation of the rock-bolts and time for the mortar to cure, the walers were installed and the nuts of the bolts installed and torqued to an equivalent 50kN bolt load.

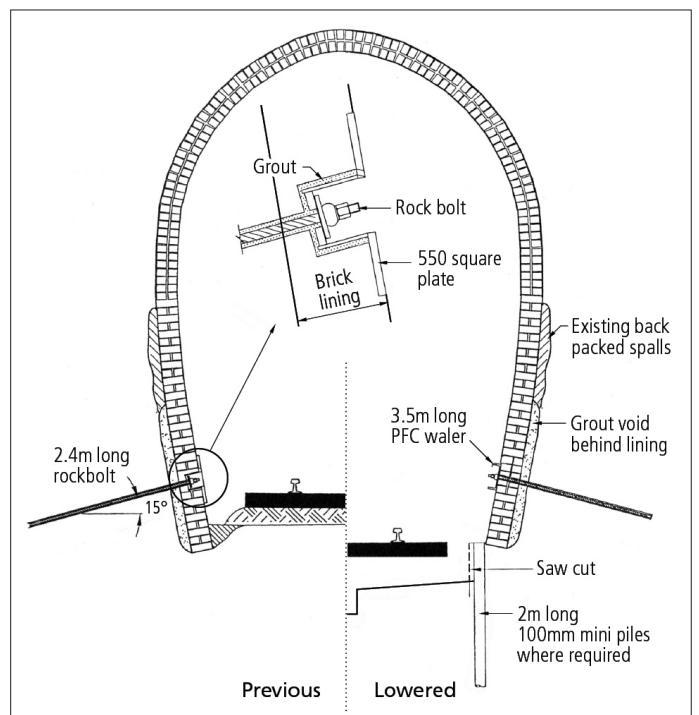
#### Figure 4 Johnsonville tunnel invert lowering

After the workshop, construction drawings and specifications, and building consent applications were developed for the general arrangements shown in Figure 4. To address the concerns of variable ground conditions, alternative designs were developed for two classes of ground, "Good" and "Poor", with loadings based on Terzaghi (1968). It was assumed that lateral support would be initially provided assuming "Good" ground conditions given that there was no evidence of significant poor ground or water inflow from the, albeit widely spaced, investigation bore holes or from lining inspections. The design included the ability to increase the amount of lateral support (closer spaced rock bolts where walers were used) if inspections of the invert after exposure for lowering indicated "Poor" ground conditions.

A major consideration was the need to obtain Building Consents and the requirement for all structural components to have a design life of 50 years. For the rock bolts this implied provision of a double corrosion protection system. The rock bolt types previously used on the NIMT and Manawatu Gorge lowering had only a single protection system (galvanising). A proprietary bolt system (Strata Control CT - similar in principle to the Dywidag DCP system) was identified which provided double corrosion protection, the first layer being provided by a HDPE sheath and the second by grout confined between the sheath and the bolt. Potential drawbacks recognised with this system were that when the bolt is installed initial tension is applied (prior to grouting) using a mechanical expansion shell anchorage and, once the bolt has been grouted, it is not possible to re-tension it or remove any hardware between the head of the bolt and the wall.
